Assessment of Distress At Mt. San Antonio Stadium

Subject: *Assessment of the Distress at Mt. San Antonio Stadium*
 IDS Project Number: 29.157.03

MTSAC Stadium Distress - Structural Evaluation

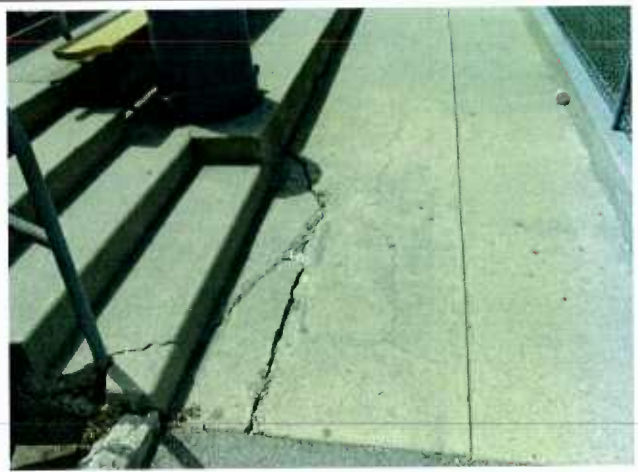
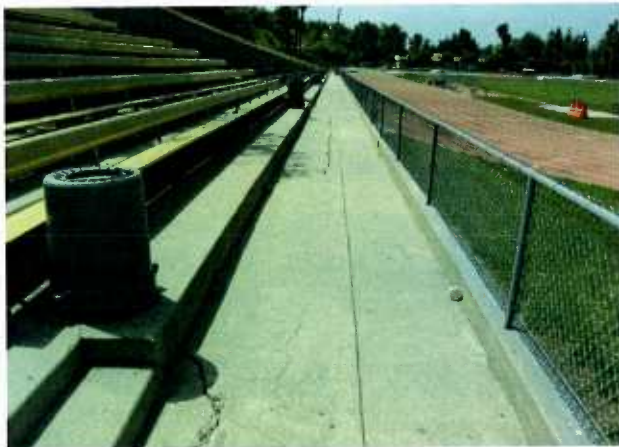
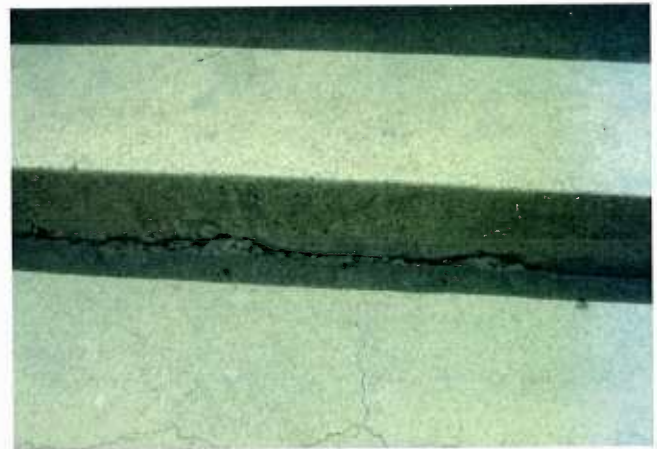
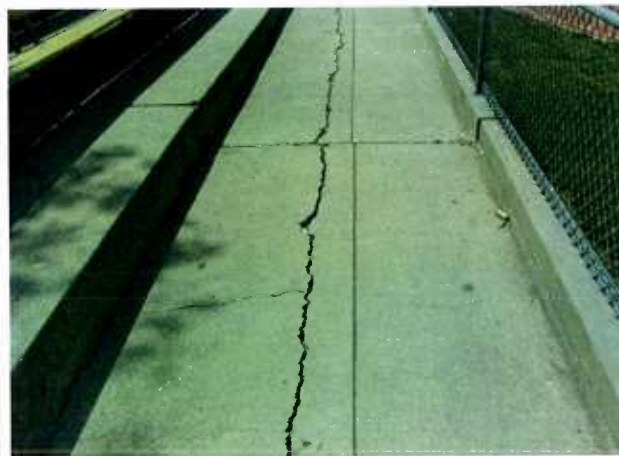
Item #	Description	Ref. Photo	Measurements	Recommended Action	Rough Constr. Cost
S1	Large cracking at slab on grade initiating from face of steps extending to the center of slab. Resulted in full-depth rupture of the slab with visible vertical offset.	S1a to S1d	75 ft	Damaged portion of the slab shall be demolished to pour new concrete and tied to existing slab using epoxy dowels.	\$13,400
S2	Top of concrete retaining wall is tilted. This is possibly caused by rotation of the foundation due to the soil and water pressure and has created slab rupture indicated in item 1.	S2a & S2b	4ft tall & 36 ft long	Retaining wall to be periodically monitored for further rotation and future reconstruction.	A/R
S3	Cracking at slab with width $\pm 1/8$ "	S3	10 ft	Infill with epoxy injection.	\$1,000
S4	Separation of concrete at the bottom of the step	S4	16 ft	To be sealed with epoxy injection or other means.	\$1,200

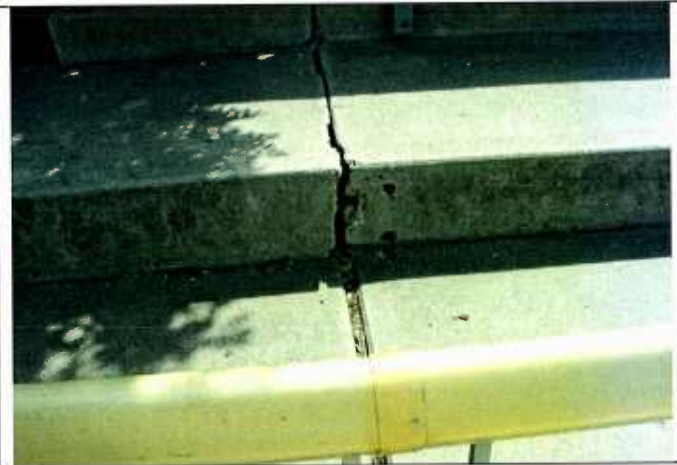
Photo S5:

S5	Exposed bar at joint	S5		Cover bar with epoxy coating.	\$150
S6	Concrete break down at railing support	S6a & S6b	4 plcs	Remove broken and cracked concrete around railing. Place new concrete repair mortar and connect to existing by epoxy dowels.	\$1,700
S7	Approximately 2/3 of the wood seats are rotten and damaged. Connection screws are loose and separated in many locations.	S7a to S7i	Approx. 5,000 linear ft	Replace all the seats.	\$205,000
S8	Slab reinforcing is exposed	S8a & S8b	8 plcs	Infill with epoxy to restore original shape and provide cover for exposed bar.	\$1,350
S9	Separation of concrete at the bottom of the step	S9	60ft	To be sealed with epoxy injection or other means.	\$4,500
S10	Concrete break down with tripping hazard. Possible nest for snakes	S10a & S10b	6ft	Remove broken and cracked concrete . Pour new concrete and connect to existing by epoxy dowels.	\$1,200
S11	Vertical offset of ± 2 " between walkway and seat section. This is due to differential settlement between south and north portion of the stand. The south portion was added in 1957 and is supported by concrete columns, beams and footings while the north portion is older construction (probably) with slab on grade and shows more settlement.	S11a to S11d	6 plcs	Some portion of the concrete slab shall be demolished and new concrete to be poured for smooth leveling between two sides.	\$10,500

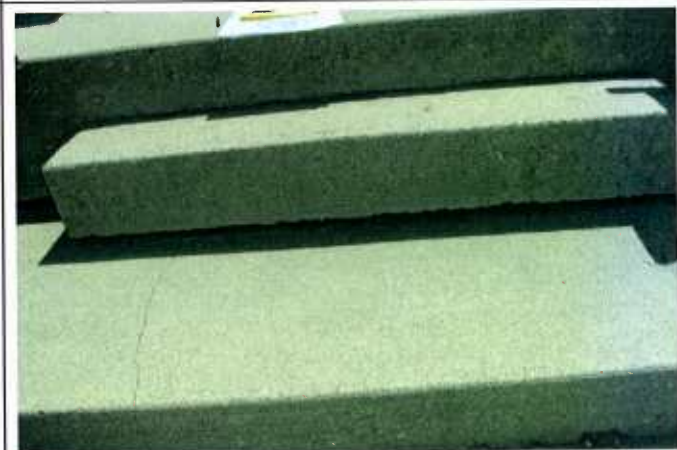
Photo S12:

S12	Separation of concrete at the bottom of the step ± 2 "	S12	6 ft	To be sealed with epoxy injection or other means.	\$225
S13	Vertical offset of ± 1 " at separation joint with tripping hazard	S13	20 ft	Some portions of the concrete shall be demolished and new concrete to be poured for smooth leveling between two sides.	\$4,500

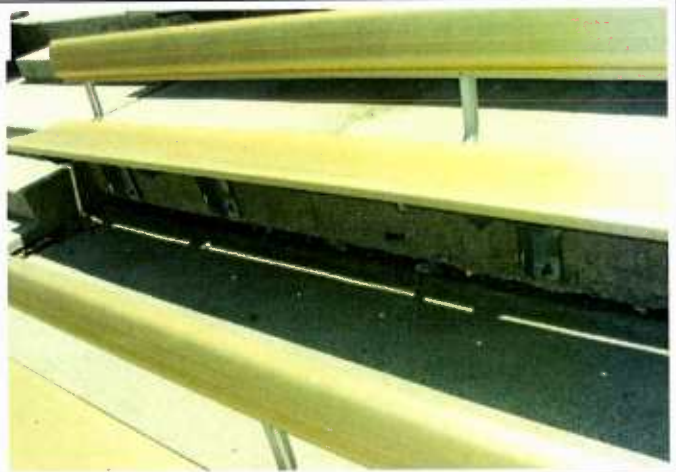
Photo S14:

S14	Large separation of concrete at the bottom of the step ±2"	S14	40ft	To be sealed with epoxy injection or other means.	\$1,500
S15	Vertical offset of ±1/2" at separation joint with tripping hazard	S15	10 plcs	Some portion of the concrete slab shall be demolished and new concrete to be poured for smooth leveling between two sides.	\$6,300
S16	Vertical offset of ±1/2" at separation joint with tripping hazard	S16	4 plcs	Some portion of the concrete slab shall be demolished and new concrete to be poured for smooth transition between two sides.	\$3,900
S17	Separation of concrete at the bottom of the step ±2"	S17	50ft	To be sealed with epoxy injection or other means.	\$3,000
S18	Separation of concrete at the bottom of the step ±1"	S18	40ft	To be sealed with epoxy injection or other means.	\$2,400
S19	Separation of concrete at the bottom of the step ±1"	S19	30 ft	To be sealed with epoxy injection or other means.	\$2,000

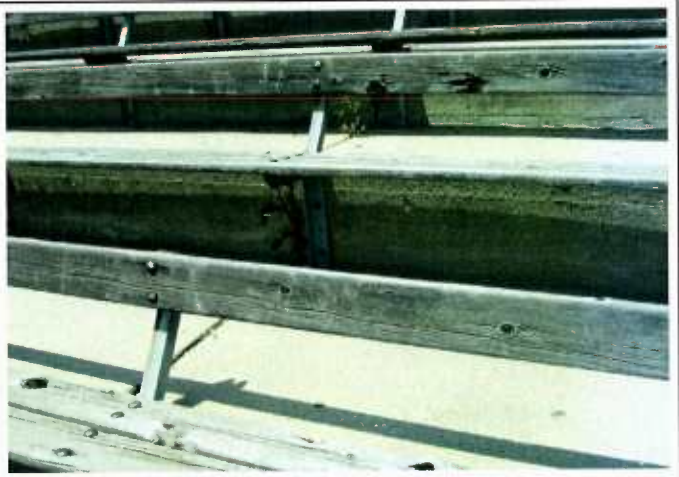
Photo S20:

S20	Vegetation inside construction joints	S20		Clean all the vegetation and trash.	\$2,600
S21	Approximately 2/3 of the Wood seats are rotten and damaged, Connection screws are loose and separated in many locations. Some of the seats are totally broken.	S21	Approx. 6,500 linear ft	Replace all the seats.	\$265,000
S22	Separation of concrete at the bottom of the step ±1"	S22	60 ft	To be sealed with epoxy injection or other means.	\$3,600
S23	Vertical offset of ±1/2" at separation joint with tripping hazard	S23	6 plcs	Some portion of the concrete slab shall be demolished and new concrete to be poured for smooth leveling between two sides.	\$4,000
S24	Cracking at slab with width ±1/8"	S24a & S24b	60 ft	Infill with epoxy injection. Concrete around seat support shall be demolished and new concrete to be poured with epoxy dowel connection.	\$6,800
S25	Damaged concrete with exposed bar and slab cracking	S25	6 ft	Remove damaged portions of concrete and infill with epoxy injection.	\$400

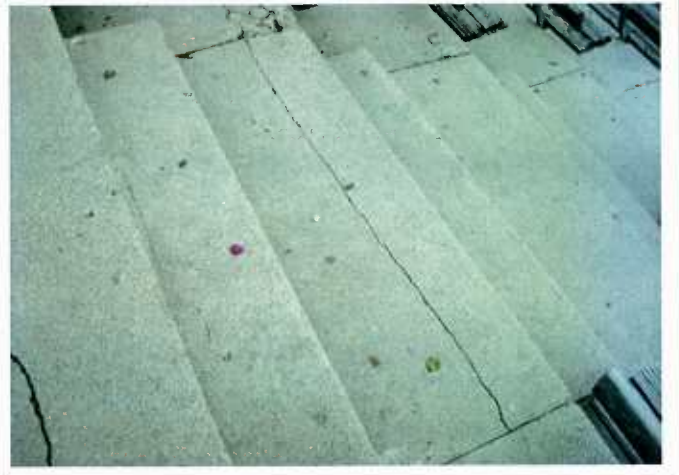
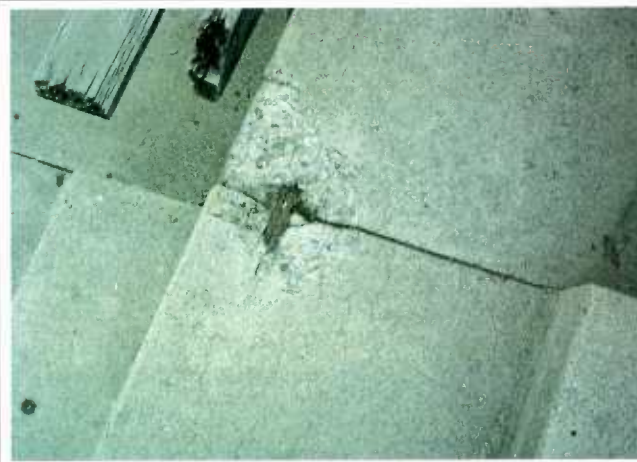
S25	Exposed bar at joint	S26a & S26b	8plcs	Cover bar with epoxy coating.	\$2,000
S26	Cracking at slab with width less tahn 1/8"		1,000 linear ft (assumed)	Cover bar Sealant.	\$12,000

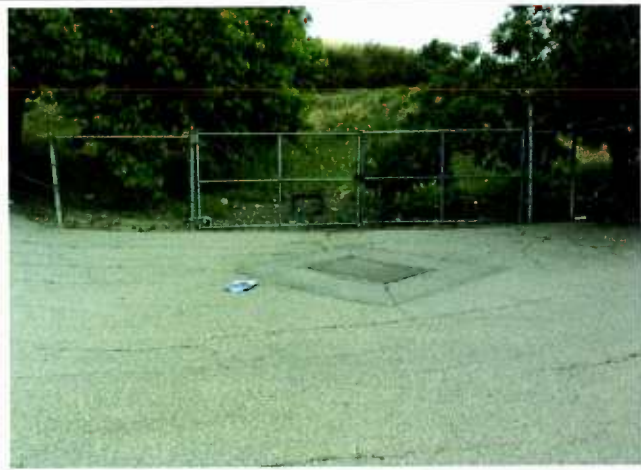
Photo C1:

Item #	Description	Ref. Photo	Measurements	Recommended Action	Estimated Constr. Costs
C1	At the proposed, 9-3-1957 Headwall location, a hole was cut at the top of the 30" CMP and a protective chain link screen box constructed over top of the hole. This new drainage point for the surface water coming from the East Stand area was observed to be silted over reducing the effect of the drain.	C1		Remove siltation, remove solid plate cover. Repair chain link fence guard. Install perforated cover over existing hole and secure to CMP	\$1,800
C2	The north East Stand entry point at the lower left corner of the entry steps; water is draining over the constructed concrete "V" ditch and flowing onto the asphalt drive area. This is due to excessive siltation build at the "V" ditch turning point.	C2		Remove siltation	\$250
C3	At the upper most elevation, the water from the high side of the sidewalk was being redirected to a lower point of the sidewalk, causing water flow over the concrete sidewalk to the earthen area. this new water direction created an undercutting of the sidewalk and exposing the underside of the walk by 1'-0" to 2'-0". This redirection is due to ground settlement, of 1 to 2 inches of the upper "V" ditch section.			At settlement area re-grade the area for positive drainage into the "V" ditch. Slurry mix the area of side walk that has been under cut and re-grade the landscape area for positive water flow.	\$7,700

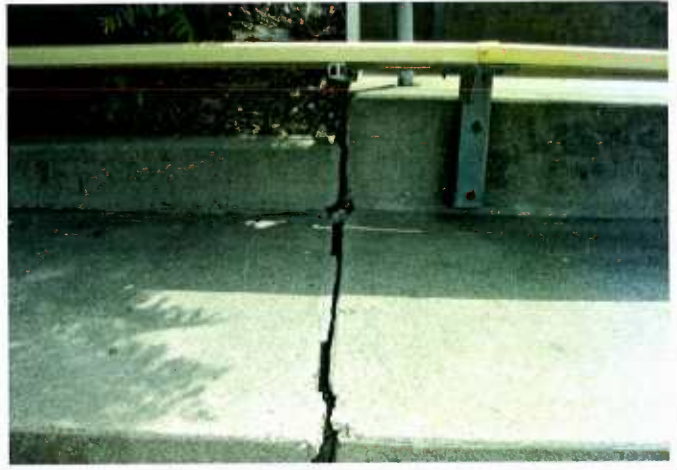
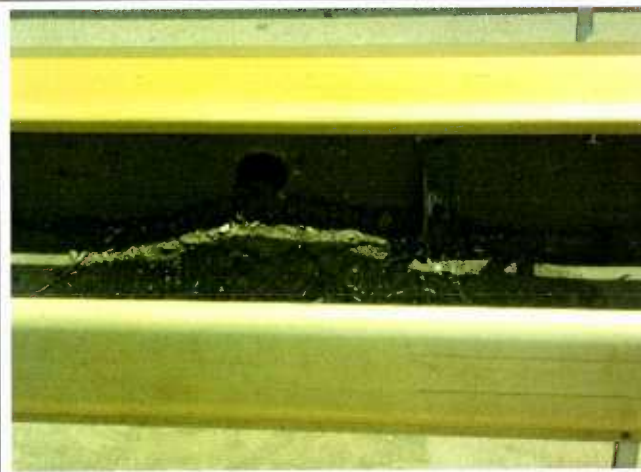
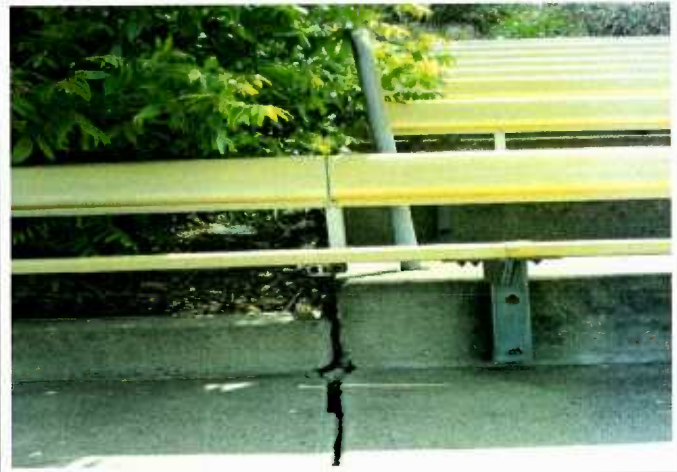
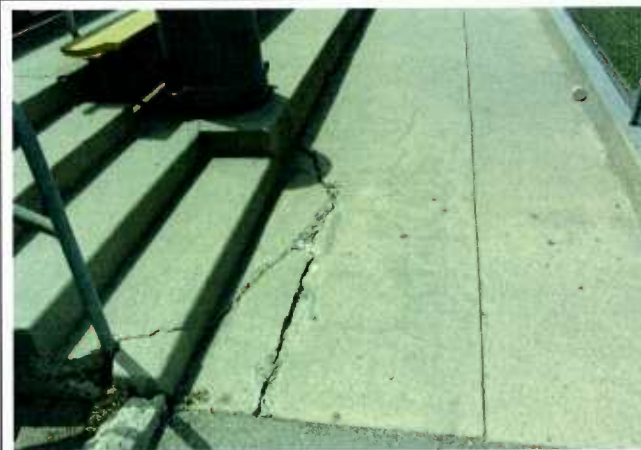
C4	This excessive water flow breached and silted over the upper concrete "V" ditch for the lower Stands, causing water to flow over the stands into existing cracks and butt joints. Several weep holes have visible siltation coming from them.	C4a to C4e		Remove siltation. At all points at both East and West Stands where the concrete "V" ditches make a 90 degree down turn, a concrete based material should be constructed at the upper most corner to direct the water away from going into the stand.	\$1,700
C5	At the top of the East Stand behind the light towers, the first "V" ditch, on the east side of the chain link fence, was non-existent. No exploratory measures were taken at this time			Remove siltation	\$7,500
C6	At the South side of the East Stand area; several under sidewalk drains were clogged with siltation making the drains inoperable.			Remove siltation	\$400
C7	The south side of the East Stand "V" ditches were also silted to the point they were inoperable.	C7		Remove siltation	\$700
